Clay Biggings

OF THE TAY
LANDSCAPE 2

*our survey of
147 surviving
earth buildings*

Volume 2: Earth Building Survey

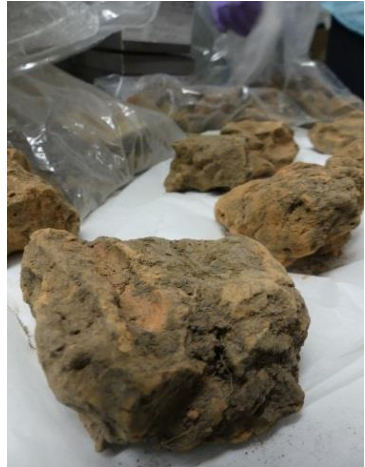
ASSESSMENT: The legionary fortress at Carpow was a massive structure comprising many substantial buildings within an enclosure of ditches and walls. The 11 hectare site was home to about 3,000 men. The site was systematically destroyed by the Romans at the end of their occupation around 220 CE and no structures remain above ground. The site has been investigated archaeologically several times and identified the use of clay, both fired and unfired. No clay mortared masonry was found, but there were turf ramparts and large quantities of wattle and daub, as well as use for floors and drainage. Daub fragments are in the custody of McManus Galleries Dundee.

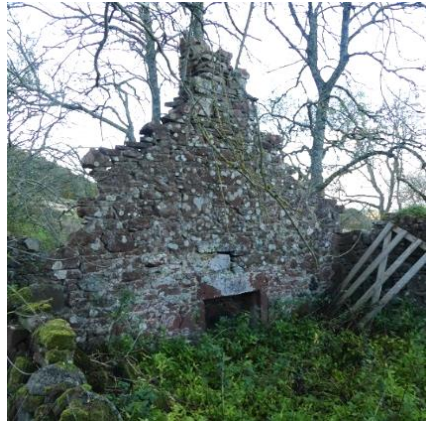
Address:..... **BURNSIDE COTTAGE & SMITHY**
Pitkeathly Mains

ASSESSMENT: There are substantial remains of 2 buildings with clay bonded random rubble walls in poor condition. Shown roofed on 1866 OS maps, they were gone by the 1920 map. Reference to thatch. The site is located not far from a map reference for Clayfolds. There was a planning application 2012 for redevelopment. Surveyed by LD, SW & TM.

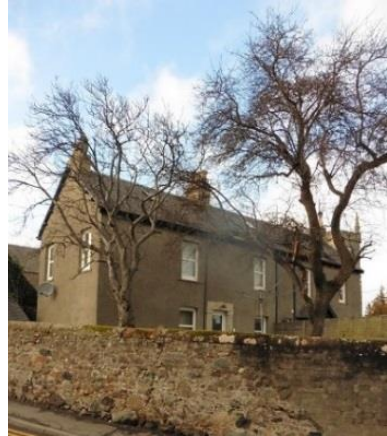
ASSESSMENT: This is thought to be a typical example of a 19th century mudwall 2 storey semi-detached house. Mudwall was not seen on this building, but in 2015 a patch fell of the gable to the abutting building and revealed mudwall beneath (TM). Apart from cement render the building seems in good condition.

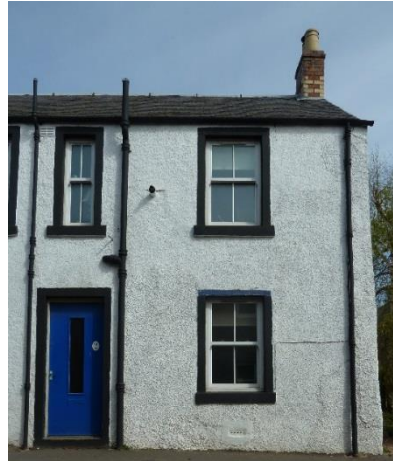
ASSESSMENT: This is a typical mudwall house with notable batter to the wall. It is cement rendered, but otherwise appears in fair condition.

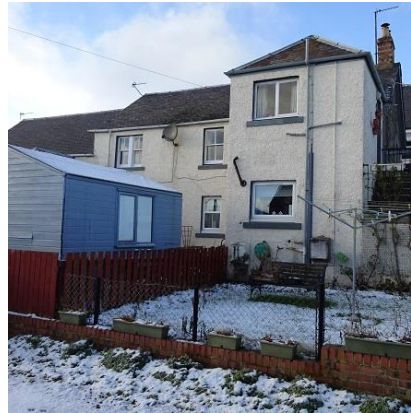
ASSESSMENT: This is a typical mudwall house with modern extension. The main walls front and back are clay. It is cement rendered, but otherwise appears in fair condition. It appears on the 1st edition OS map of 1854.

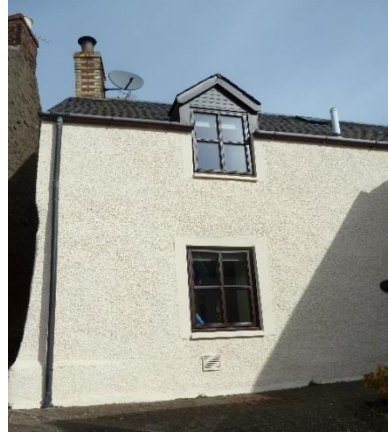
ASSESSMENT: This is thought to be a mudwall house, with sign of historic alterations. It is cement rendered, but otherwise appears in fair condition.

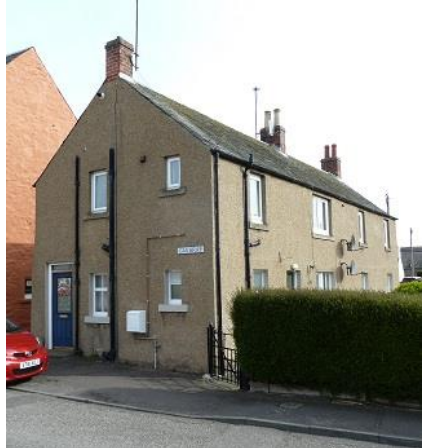
ASSESSMENT: A late example of a mudwall town house, with later window alterations. Cement render appears in reasonable condition. The single flue chimney does not match the others on the building.

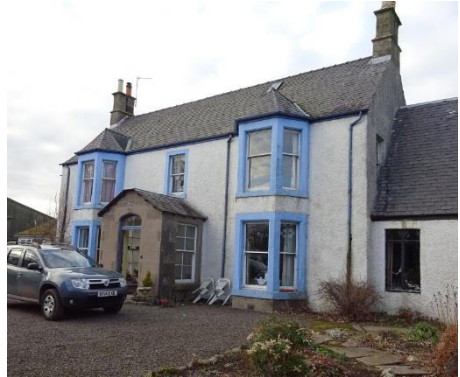
ASSESSMENT: Clay mortared masonry was found in an exposed internal store room wall. The owner reports that 2 types of clay are found close by, the marine clay is greyer than the boulder clay from Ninetree brae. The Listing description states it has clay & horsehair, possibly meaning plaster, but none was identified when visited by LD & TM.
