Clay Biggings

OF THE TAY
LANDSCAPE 2

*our survey of
147 surviving
earth buildings*

Volume 2: Earth Building Survey

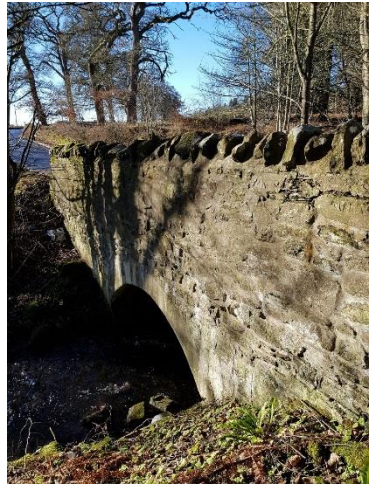
CONDITION: Good Fair Poor Ruin AT RISK

ASSESSMENT: LD & SW surveyed the bridge and identified clay mortar on 19.11.2017. The masonry also has cement pointing and it is assumed it was originally lime pointed. Photograph courtesy of Linda Dunwell.

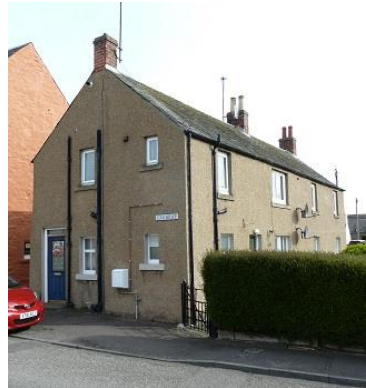
CONDITION: Good Fair Poor Ruin AT RISK

ASSESSMENT: A late example of a mudwall town house, with later window alterations. Cement render appears in reasonable condition.

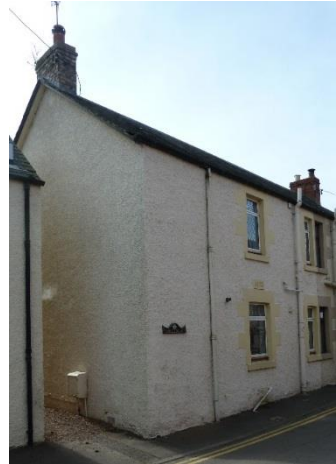
CONDITION: Good Fair Poor Ruin AT RISK

ASSESSMENT: The owner reported that originally there was a clay wall at the front. The house burnt down and after, it was rebuilt. The only remaining clay wall is in the downstairs kitchen. The next door house was completely rebuilt. A number of properties in Errol have suffered fires.

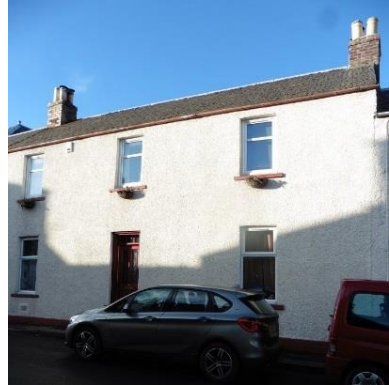
CONDITION: Good Fair Poor Ruin AT RISK

ASSESSMENT The owner said it had been rebuilt in 1870, thought to be older. Extended. No visible damp. No foundations. Two walls internally are clay.

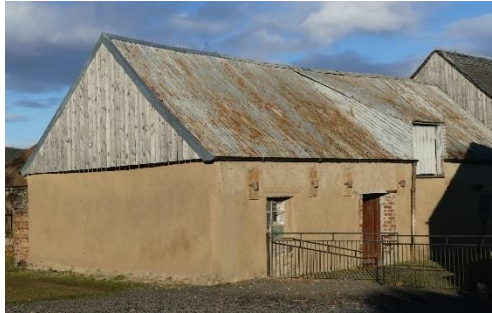
CONDITION: Good Fair Poor Ruin AT RISK

ASSESSMENT: This build appears on the 1st edition O.S. Map and shows alterations, including increasing the wall height which suggest it may have originally be a cottage. Extensive repairs were undertaken as part of the TLP. Remnants of turf roof, internal clay plaster and external lime harl were found. The repairs included a new external earth render.

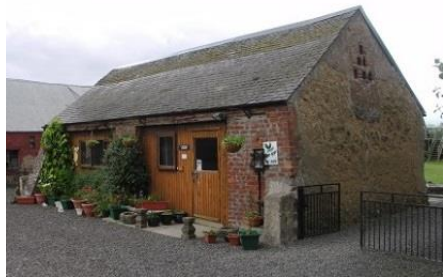
ASSESSMENT: This is named as Former Cart shed on the listing description and incorporates a pigeon loft, with entry on the south gable. The silt-rich mudwall is visible and in better condition on the north gable, than on the south where there is moss growth that does not appear to be causing significant damage. Evidence of significant alterations in brick. No internal inspection.

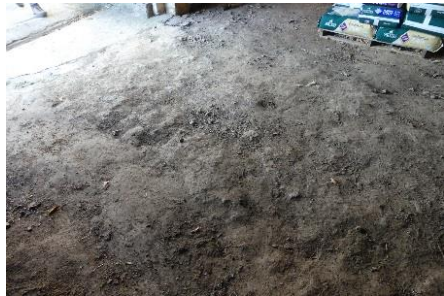
ASSESSMENT: This is one of the few surviving examples of clay floor which were found during the survey. It is a working farm floor, regularly trafficked and the owner reports it works well. The building is thought to have clay mortared masonry as well, but not mudwall.

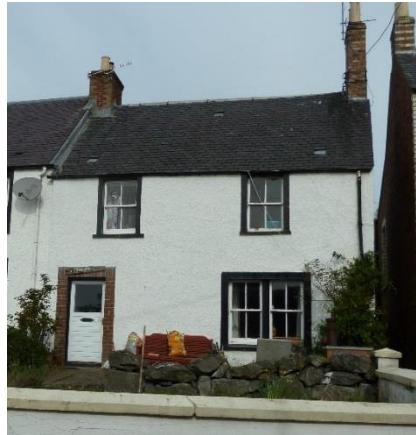
ASSESSMENT: The owner describes all the walls as clay, 600mm thick. The building was subject to a fire in the past and 'old tree trunks' are reported to have been found during renovation. Mudwall can be seen in the airing and electricity cupboard.

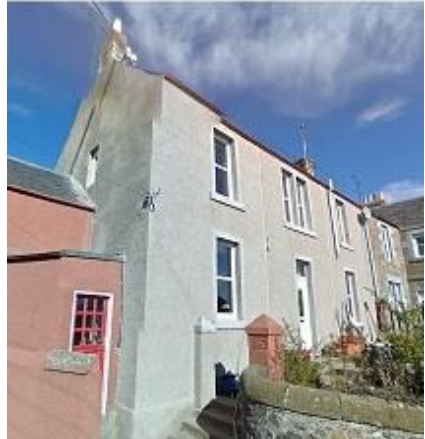
ASSESSMENT: This was identified as mudwall in 2012, but no details have been verified. There are cracks in the cement render.

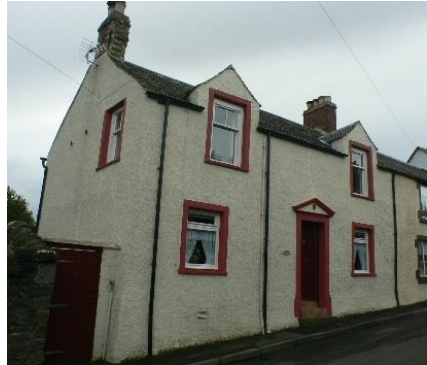
ASSESSMENT: This house shows typical characteristics of mudwall house, with a battered base, but all concealed behind cement render, which shows some cracks.

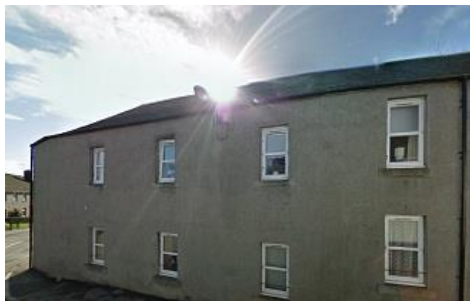
ASSESSMENT: The building is shown on 1st OS 1854 and appears to be mudwall, much altered and cement rendered. An adjacent building showed clay through a crack.

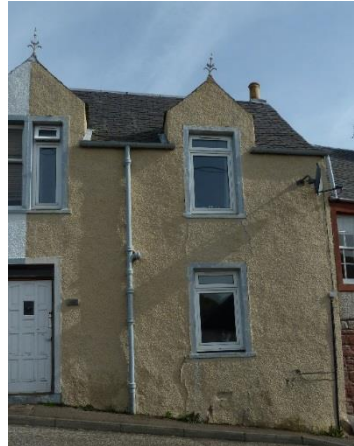
ASSESSMENT: This is a typical mudwall, semi-detached house, where mudwall was visible during render repairs to the rear wall of the neighbouring building, Riverview. The render is cement.

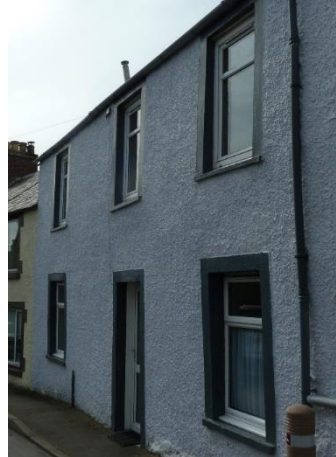
ASSESSMENT: The owner confirmed clay construction and it appears a typical mudwall building in good condition, apart from cement render.

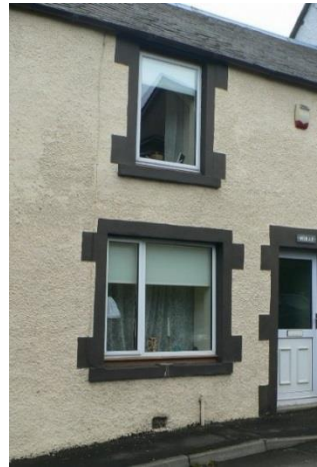
ASSESSMENT: The main body of the house is mudwall, which has been confirmed by the owner. It has a stone foundation course. First noted on valuation rolls in 1854.

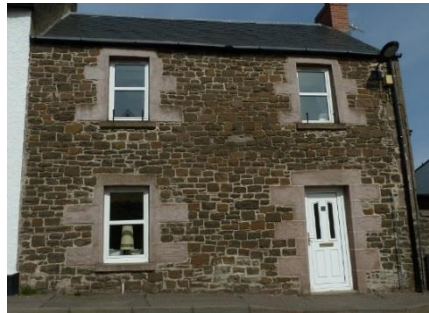
CONDITION ASSESSMENT: This was formerly two properties, merged when it was renovated in 2007. The walls are 2ft thick with a stone front façade, cement pointed, and cement rendered side and rear. The owner found mudwall in the attic. A bit of damp is reported near windows. The uninsulated plasterboard linings are reported to be 1ft away from the mudwall which 'is crumbly'.

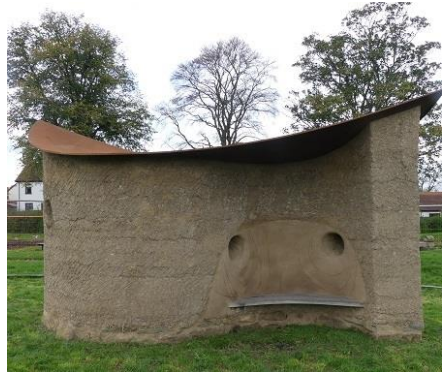
ASSESSMENT: This park shelter was built in 2017 by local Tay Landscape volunteers, and trainees under the guidance of mudmason Becky Little of Rebeath. It is the first mudwall structure to be built in the area for 100 years. It features a clay-mortared base on gravel foundations, mudwall with local clay plaster and a Cor-ten steel roof.

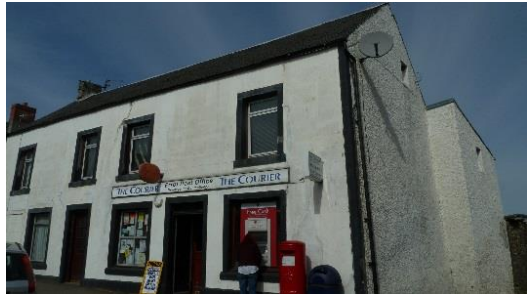
ASSESSMENT: The building is mudwall with cement render, which is cracked in places. The east end ground floor is the post office, believed to have formerly housed a cobbler's and/or a saddlers. The original structure is of mudwall construction built off a boulder base, later raised in brick. (see Viv Whyte A study of historic earth structures in the Carse of Gowrie, 2010, p118-124).

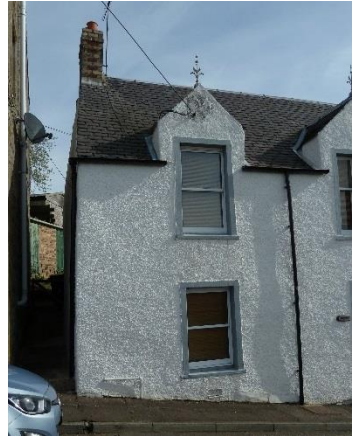
ASSESSMENT: The rear wall was seen to be mudwall with cement render when under repair in 2016.

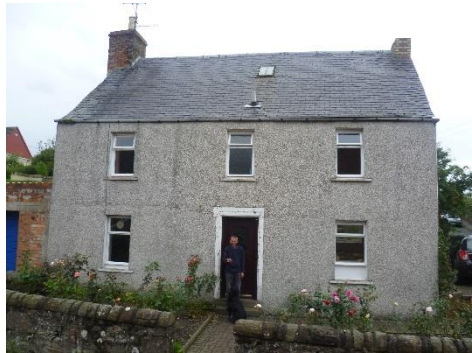
ASSESSMENT: The house is present on the first edition OS Map 1860. All walls are mudwall, excluding the recent extension, with a brick built chimney stack. Lime render was removed in 1970 and replaced with wire lath and sky marble chip cement roughcast. Title deeds to the property grant a feu duty with rights to cut reeds from the Tay and dig clay, so it originally must have been thatched.

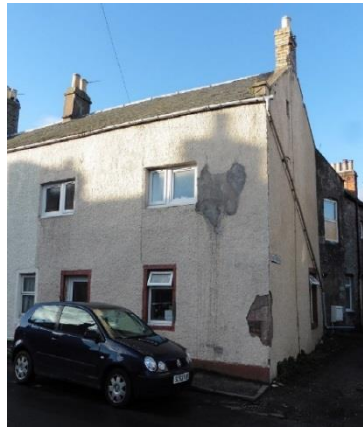
ASSESSMENT: This is a mudwall building with a clay floor under concrete. The external cracked cement render was being removed and expected to be lime harled.

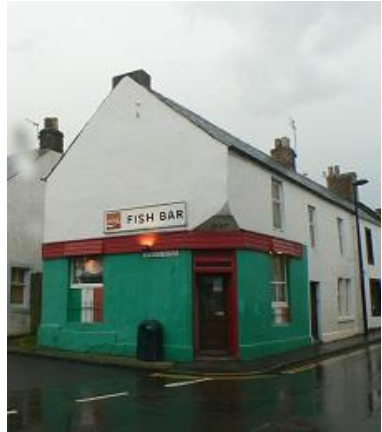
ASSESSMENT: The chip shop an unusual mudwall building with a corner doorway and corbel over. The cement rendered is cracked.

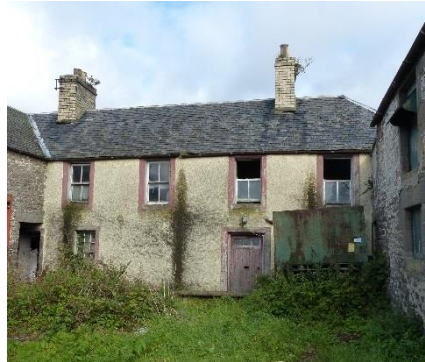
ASSESSMENT: The Horn Farmhouse is an unusual mudwall building, with a low ground storey and generous first floor. Most of the walls are cement rendered, but the west wall is stone faced. It is recorded as being designed or altered by a Dundee Architect in the 19th century. A Latin inscription above the entrance door is translated as 'a mud house is my defence'. The building has been disused for several decades and poorly maintained. Leaking rones led to the collapse of a section of mudwall, which was repaired through the TLP. It remains unused, however and at risk form further decay.

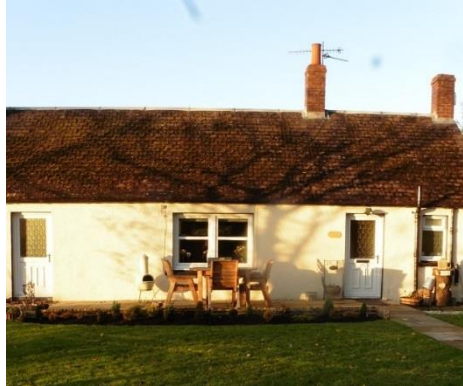
ASSESSMENT: This cottage is assumed to be mudwall as the adjacent Bee Cottage is confirmed mudwall. On first edition Ordnance Survey map.

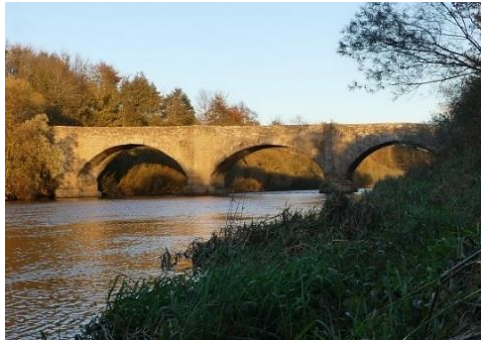
ASSESSMENT: The 18th C. bridge is single carriageway over 3 arches. TM & LD found clay/lime mortar in the parapet, behind modern cement pointing in poor condition.

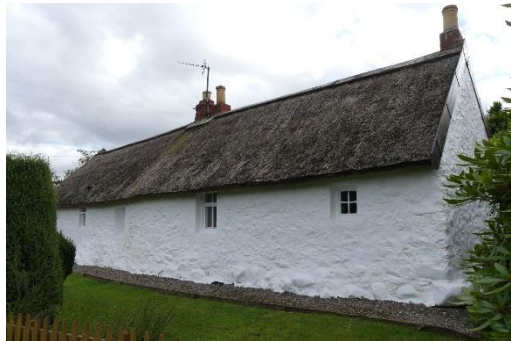
ASSESSMENT Single storey thatched cottage, highly likely to be clay mortared masonry, given age, location and precedent. Dark stains indicate clay mortar

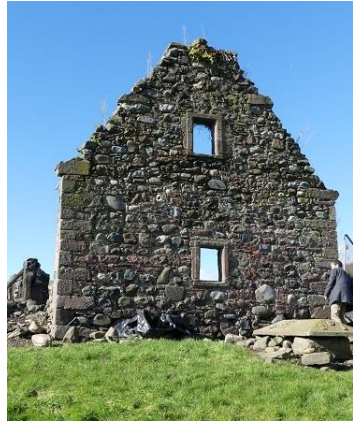
ASSESSMENT: The remains of the pre-Reformation parish church, which was abandoned in the early 17th century. It is 20m by 6.4m with walls 0.8m thick of random coursed rubble with freestone quoins and dressings. The east gable survives to its full height and other walls to varying height. Original sections of wall are clay mortared, with remnants of internal lime plaster, and later alterations in lime. The ruin was repaired by the TLP project and comprehensively repointed in lime, with new interpretation panels.

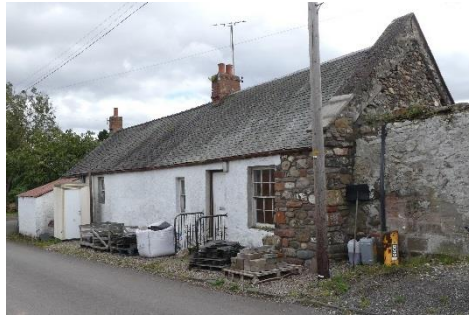
ASSESSMENT: Good example of clay mortared masonry in decay with large cracks. Previously thatched, single storey harled and slated.

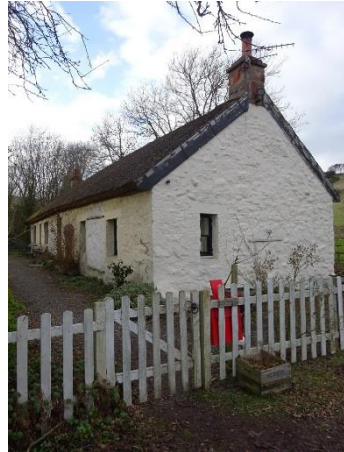
ASSESSMENT 18th century pair of cottages, united into one. The cottages have a continuous thatched roof, thatched in reed. Single storey whitewashed rubble. Wallhead slopes with ground. Brick chimneys. Highly likely to be clay mortared masonry, given age, location and precedent

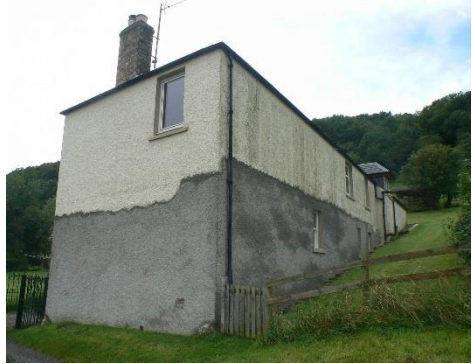
ASSESSMENT: The owners confirmed that the ground storey is mudwall, with a clear boulder base, while the upper storey was extended in brick. The building, possibly originally 2 cottages, appears on the 1st edition OS map 1843-82. The Edinburgh Advertiser newspaper of 1819 reported..."the soil of this farm is strong clay". TM & LD inspected. Modern cement render in good condition.

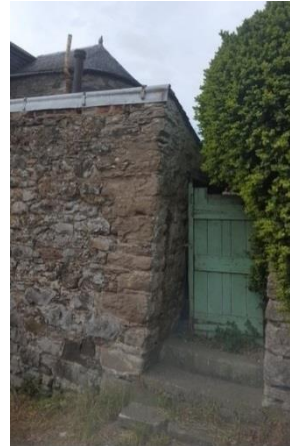
ASSESSMENT: Clay mortar was identified by LD during field work. It may indicate clay mortar in some of the more substantial 19th C buildings which could not be examined closely.

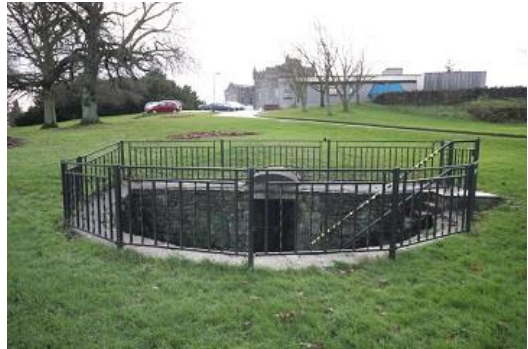
CONDITION ASSESSMENT A very early intact example of an estate icehouse, situated to the northeast of the castle. There is a semi-circular forecourt set into the sloping ground, with rubble retaining walls and a flight of steps leading down to the entrance. This is surrounded by later metal railings. The interior is brick with a passage leading to the bottle-shape ice chamber. TM & LD identified clay mortar behind lime mortar on the entrance wall. How much clay mortar is used in the main construction could not be determined.

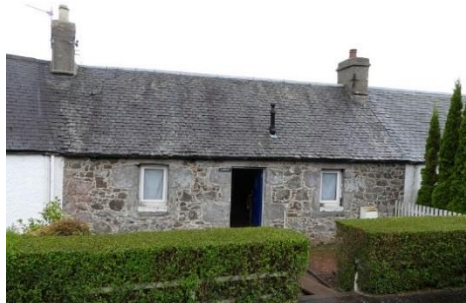
ASSESSMENT: TM & LD confirmed mud mortar 2017.08.25. Red clay mortar found in all internal walls. Clay subsoil in garden looks very similar. The owners are currently renovating, including pointing walls with lime. The concrete floor has been lifted revealing a clay floor beneath. This is one of a curved row of 4 cottages, numbers 76-82, assumed originally identical.

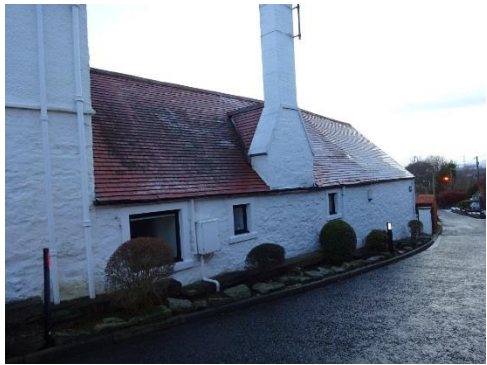
ASSESSMENT: This building is on 1st edition OS map. Highly likely to be clay mortared based on date and form.

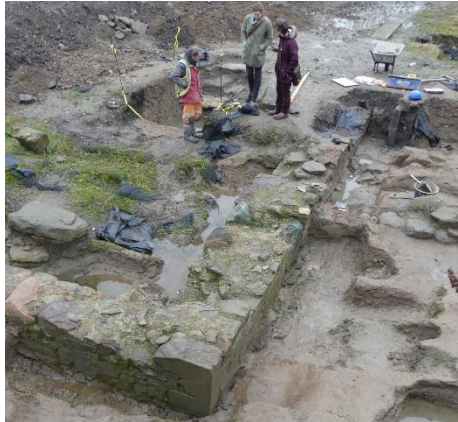
ASSESSMENT: This substantial complex of medieval masonry building lay just outside Perth city walls. Recent excavations have revealed clay mortared masonry wall bases, which are thought to have supported lime mortared upper walls.

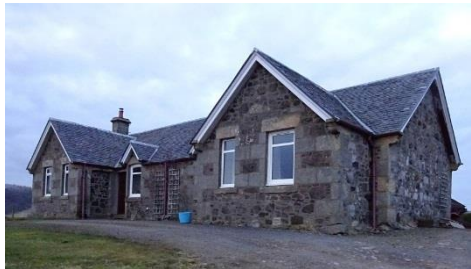
ASSESSMENT: The walls are of lime mortared whinstone but the foundations are clay bonded (Derek Hall). This arrangement of mortar is found in high status medieval buildings, and it is unusual to know the foundations of later dwellings, where mortars above ground are more readily identified.

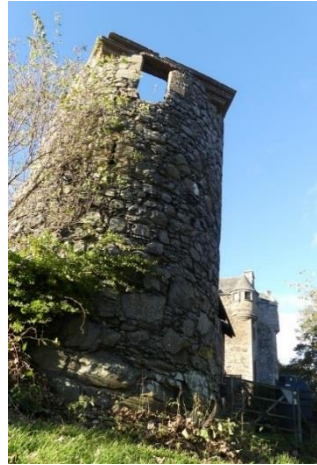
ASSESSMENT: The base of this tower is a vaulted oven, of clay-mortared masonry and with a clay floor. External pointing is lime and it is unclear whether other clay mortars in the castle are clay, or why clay could have been specially selected for an oven. This area is not normally accessible to the public, being adjacent to a domestic cottage.

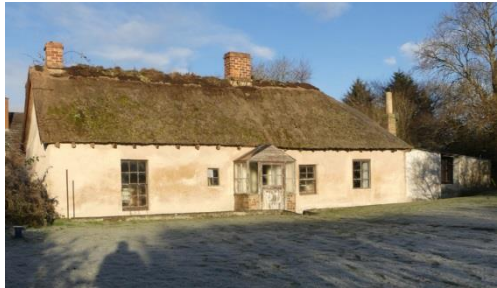
ASSESSMENT: This well-documented building is by far the best surviving example of a traditional mudwall building, with mud and stud internal partitions, wattle & daub lums and authentic thatched roof. The building has lost its original floor and has been damaged by flooding and neglect. It is not generally open to the public.

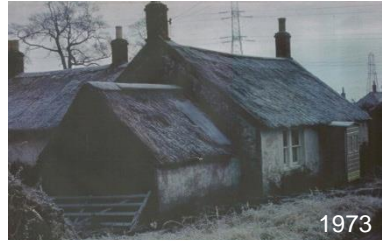
ASSESSMENT: The West Ruin was known to contain 18th century clay and straw walls attached to a larger clay-mortared rubble house. Alterations during the late 19th century, including the blocking of the rear door, the creation of a window, and the construction of a brick partition wall, which divided the house into two rooms, each with its own closet. Loss of the building's roof led to rapid decay and the remains are in active decay, though some timber elements still survive.
